## Appendix C2 - Fluvial Geomorphology Report

**Stage 2 ION Light Rail Transit  
Fluvial Geomorphic Assessment of the Preferred Route  
Region of Waterloo**

Prepared for:  
**WSP CANADA INC.**

Version 3.0  
July 2020  
Guelph, Ontario

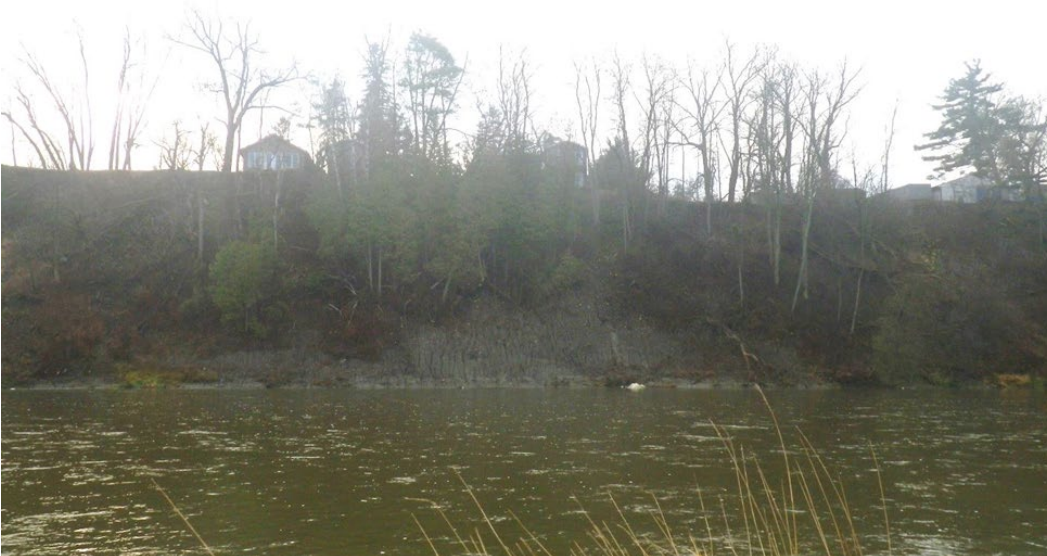
2. Grand River Reach GR-1 downstream of Allendale Road. Valley wall contact experiencing erosion along left outer bend facing downstream (southeast).

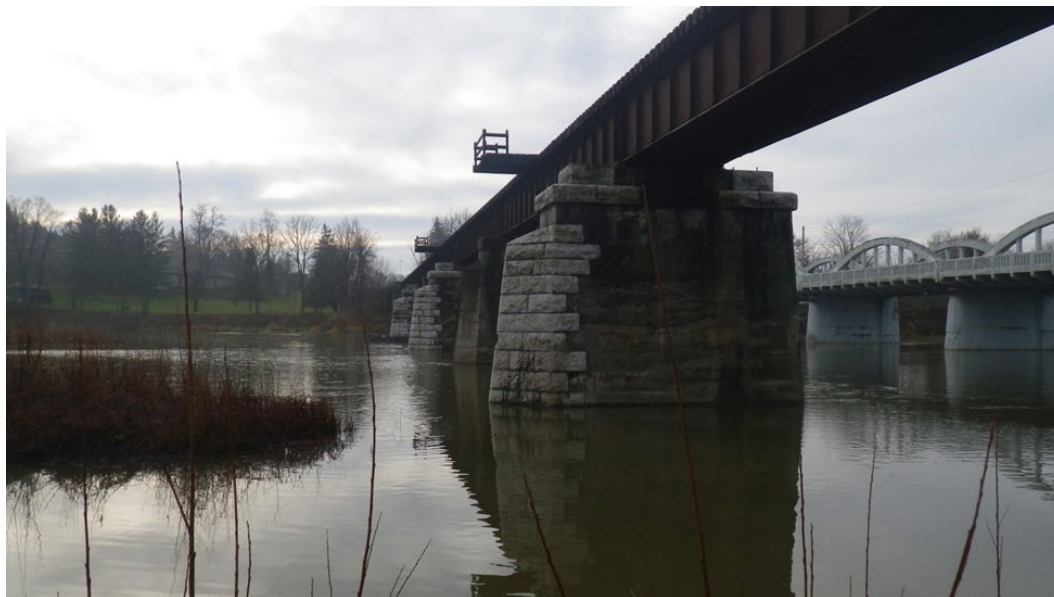
3. CPR spanning the Grand River Reach GR-1 facing left bank.

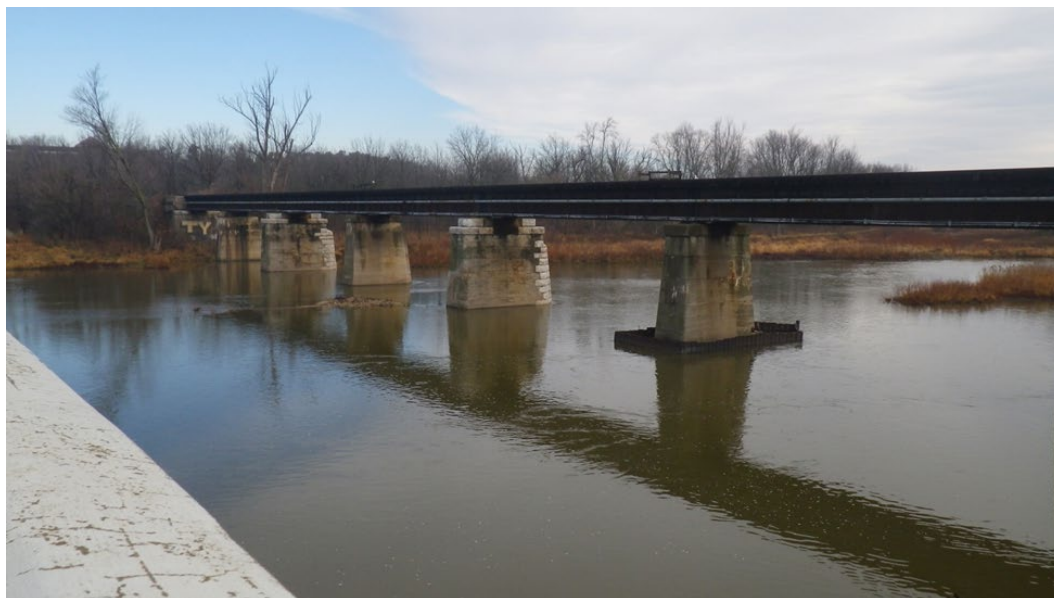
4. CPR spanning the Grand River Reach GR-1 facing right bank.

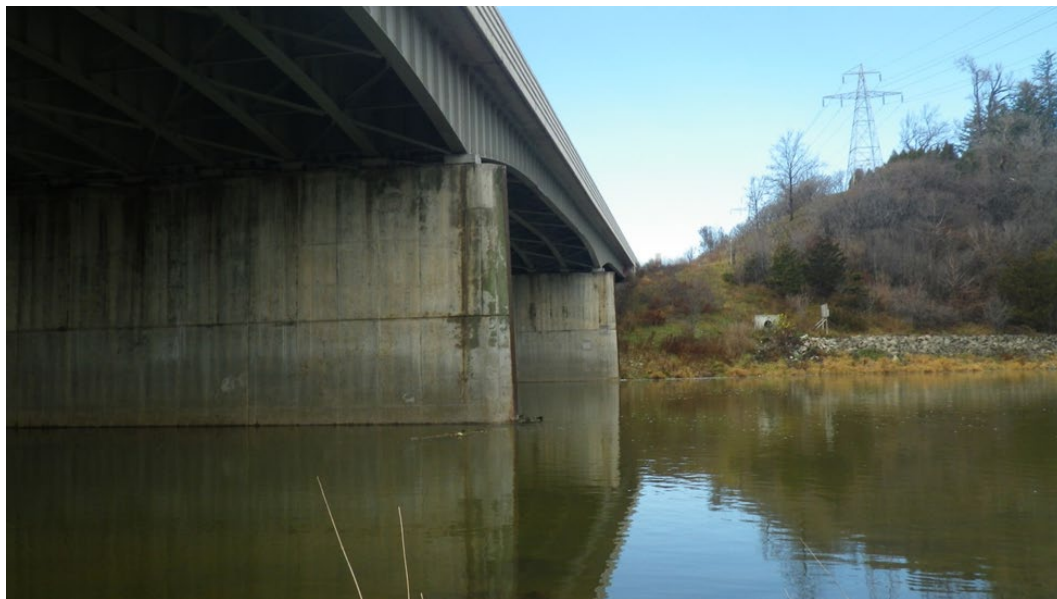
5. Highway 8 spanning Grand River Reach GR-1 towards right bank (northwest).

The Preferred Route for Stage 2 ION crosses the Grand River Reach - GR-1 parallel to the existing Highway 8 bridge. This reach of the Grand River exhibits large meanders confined by steep valley walls, which are met at meander apexes. No discernible longitudinal migration rate of meanders through the valley could be observed by comparing historical aerial photographs. Some lateral migration of the channel was observed at various locations throughout the study reach during the field investigation causing widening and localized scour at some of the existing piers at various bridges (Canadian Pacific Railway existing bridge for example).

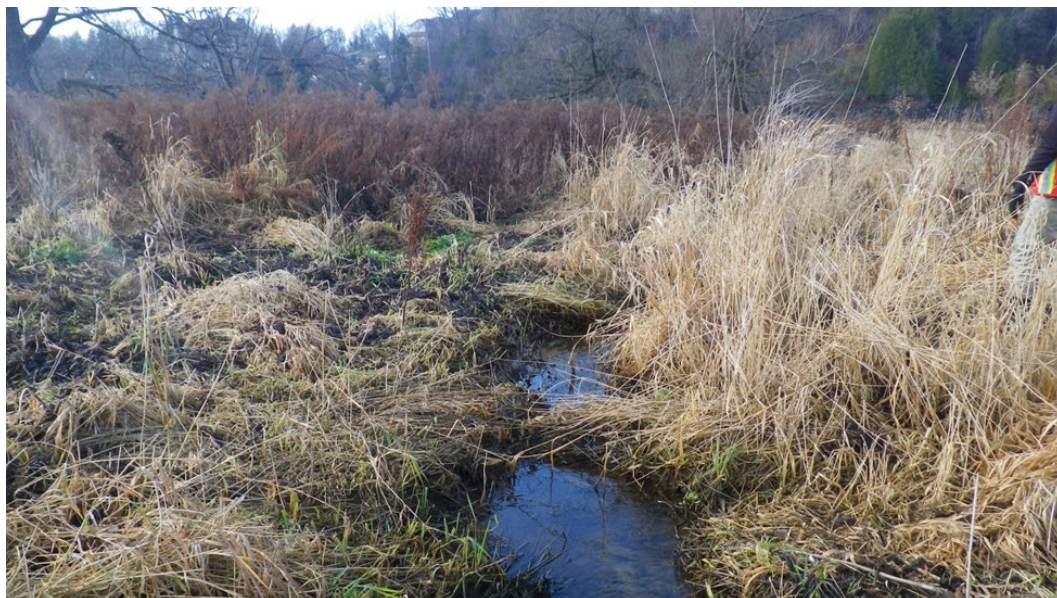
6. Freeport Creek Reach FC-1, facing downstream, near the confluence with the Grand River (southwest).

The meander belt width along Freeport Creek Reach - FC-1 was determined to be 19 m which is likely cost-prohibitive and could have an impact on road and flood elevations. Having been historically straightened, there is evidence of planimetric form adjustment. Bankfull widths ranged from 1.2 to 2.0 m. A three times bankfull width, 6.0 m span, is recommended and would allow for future channel adjustment.

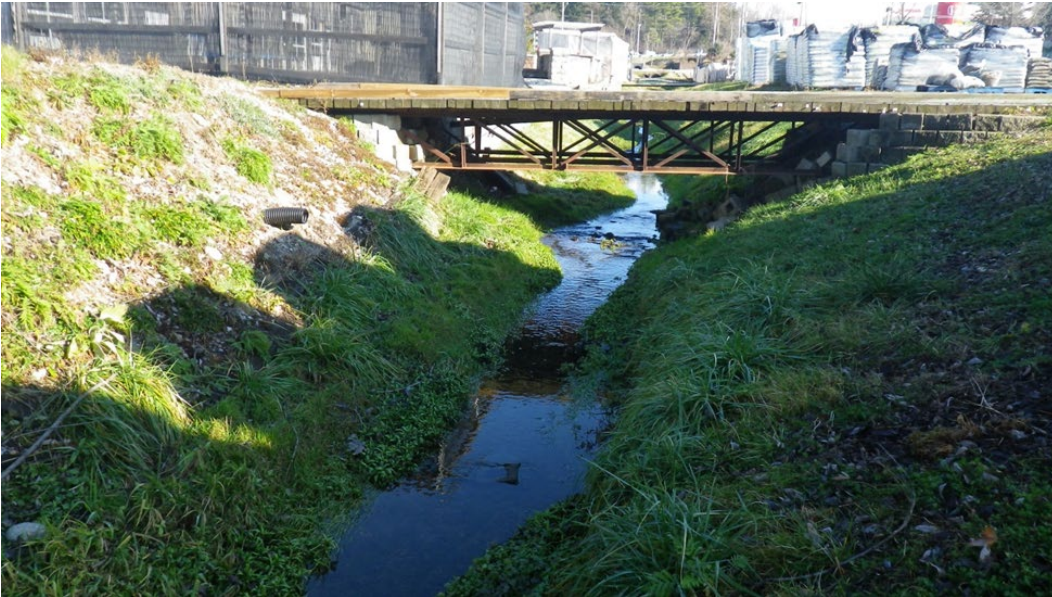
7. Freeport Creek Reach FC-1 through channelized Grand Valley Garden Village property facing upstream (east).

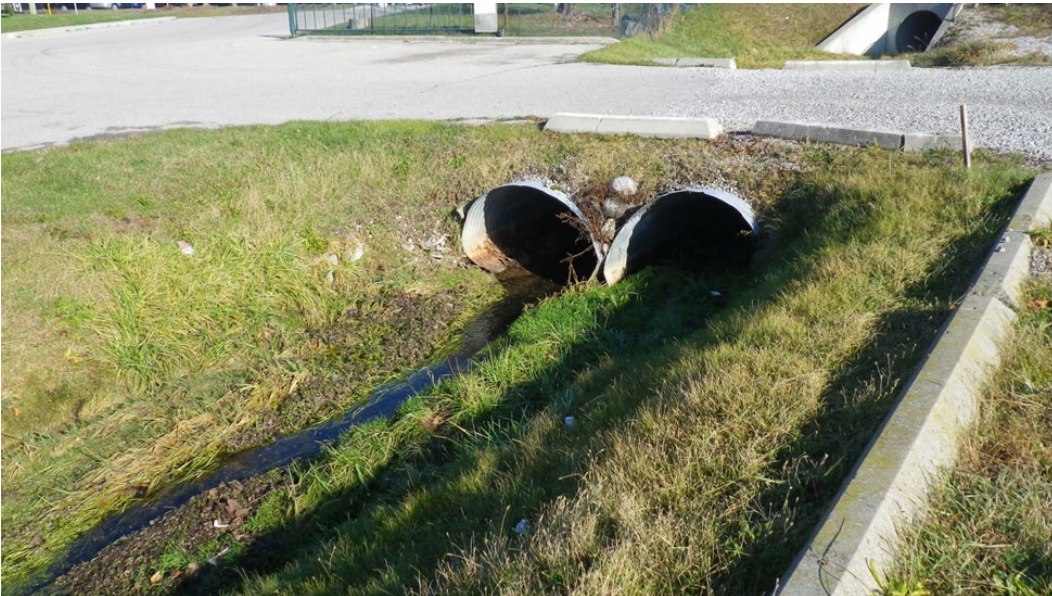
8. Freeport Creek Reach FC-1 flowing through twin corrugated steel pipes under Grand Valley Garden Village property driveway in foreground and concrete culvert in background under King Street East, facing upstream (east).

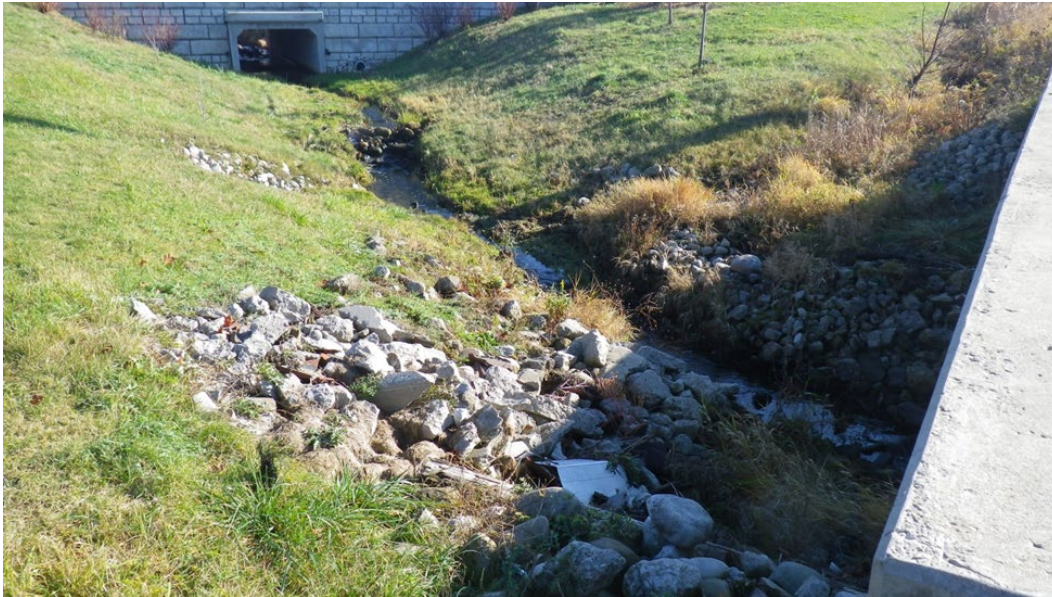
9. Freeport Creek Reach FC-1 between King Street East concrete culvert and box culvert Honda driveway.

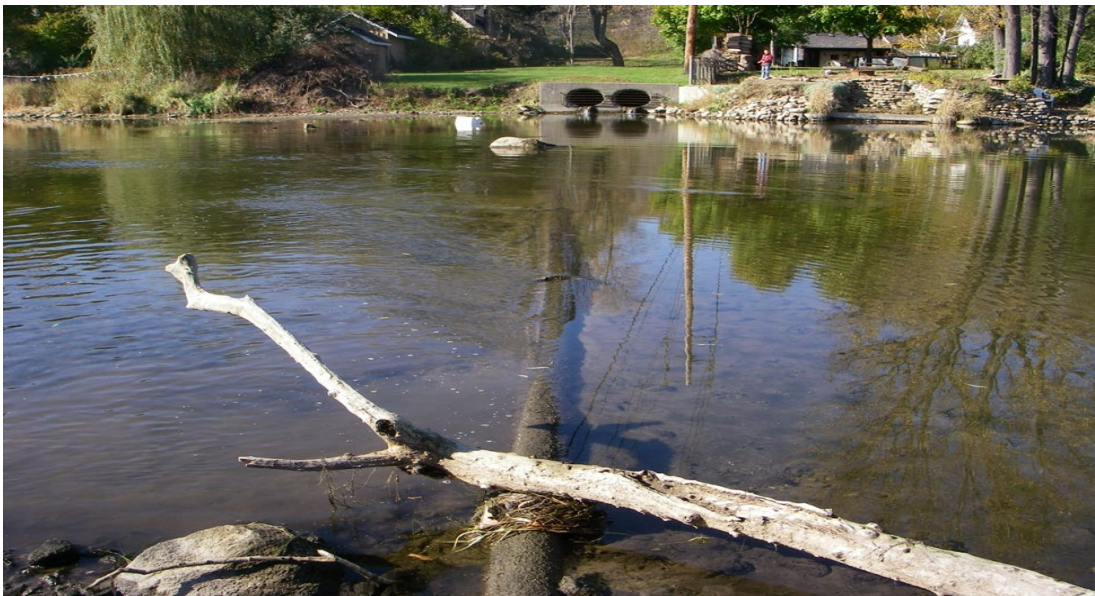
10. Speed River Reach SR-2 facing scoured and armoured right bank at outfall.

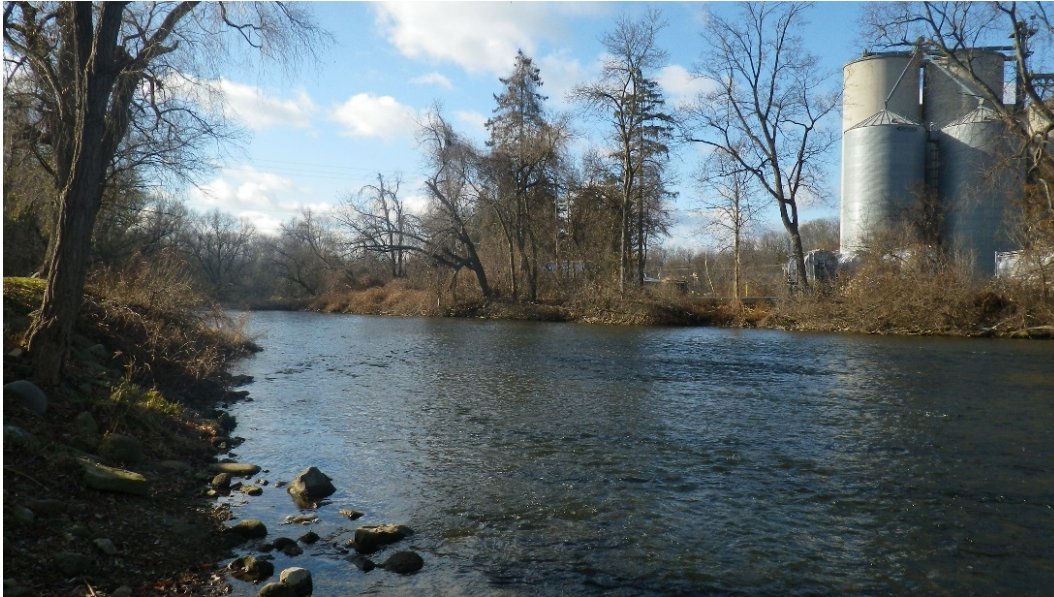
11. Speed River Reach SR-2 facing downstream from below King Street East adjacent to P&H Flour Mill.

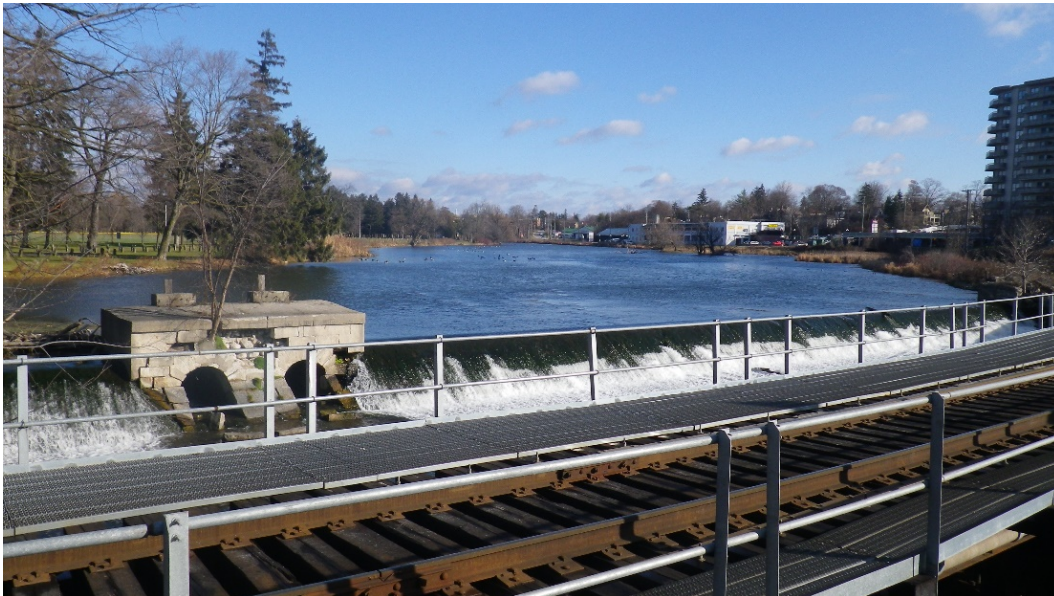
12. Speed River Reach SR-2 facing upstream from King Street East over existing rail line and Riverside Dam.

As with the Grand River, spanning the meander belt width is cost-prohibitive and deemed to be unnecessary given the stability of the Speed River and number of features that control flows and water levels, including the Riverside Dam. The Speed River along Reach SR-2 has a low sinuosity and a low gradient (0.9%) and is experiencing lateral migration toward the right bank, with evidence of erosion. This erosion toward the right bank is considered the greatest hazard to this crossing location and may require stabilization works depending on crossing design. Reach SR-2 had an approximate 100-year erosion rate of 19 m which should be considered as an erosion hazard allowance to the top of bank.

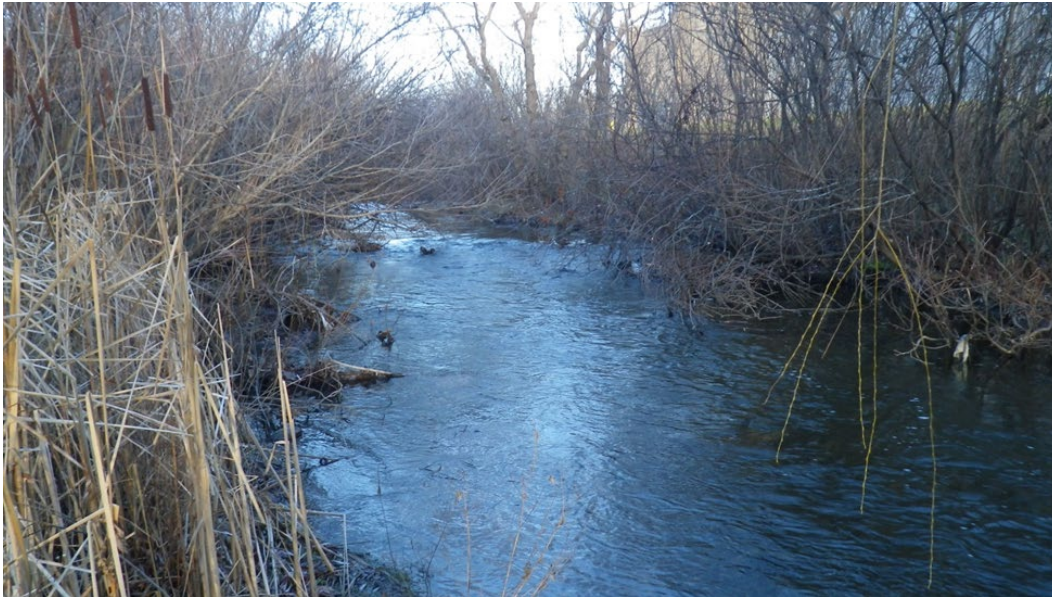
13. Mill Creek Reach MC-1 facing downstream, north of Kerr Street (southwest).

Mill Creek has been straightened along the Preferred Route and runs parallel to Beverly Street and Shad Street. There is no open channel crossing at this location; the Stage 2 ION Preferred Route does not cross Mill Creek but is located immediately adjacent to it. The existing channel is armoured to protect adjacent properties and infrastructure; however, the meander belt width delineated as part of this study suggests that the Stage 2 ION Preferred Route is within the natural hazard allowance. Maintaining the existing channel alignment (i.e., channel armouring) will be necessary to limit channel migration.

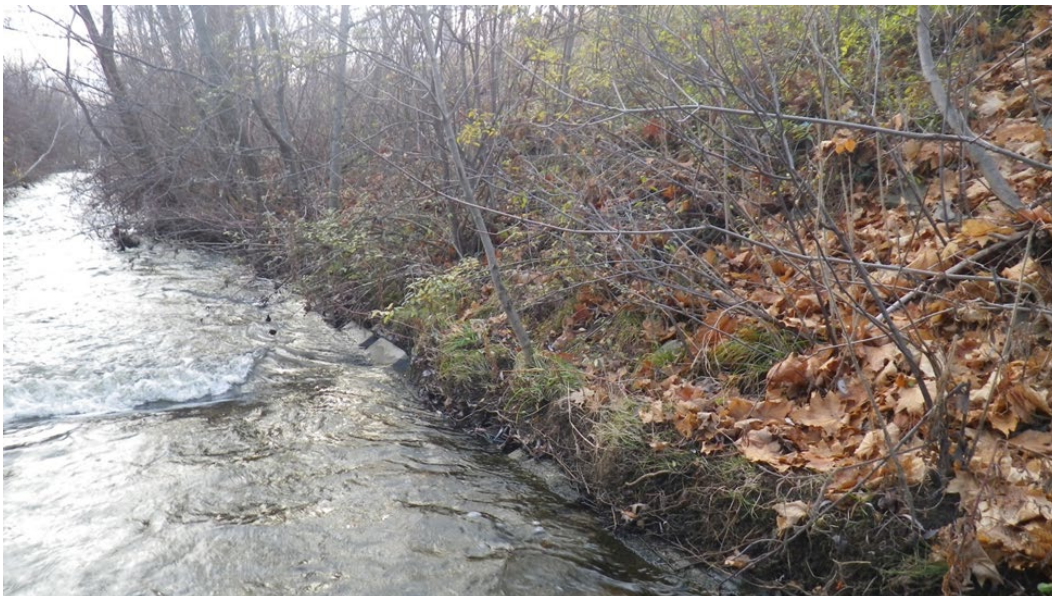
14. Mill Creek Reach MC-1 facing downstream, north of Kerr Street; tiles are lining the bed and banks through the reach (southwest).
